# **THERMAL BARRIER COATING LIFE PREDICTION MODEL DEVELOPMENT SECOND ANNUAL REPORT**

(NASA-CR-179508) THERMAL BARRIER COATING  
LIFE PREDICTION MODEL DEVELOPMENT Annual  
Report (Pratt and Whitney Aircraft) 213 p  
CSCL 11G

UNITED TECHNOLOGIES CORPORATION  
Pratt & Whitney Group  
Engineering Division

CONTRACT NAS3-23944

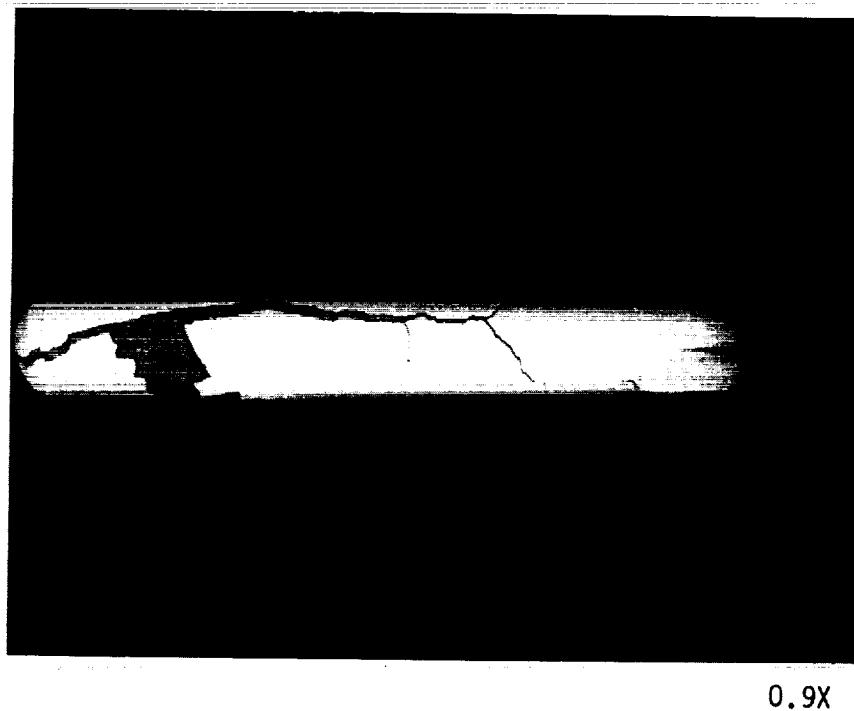
Figure 7 Photomicrograph of Typical Furnace Tested Failed Coating (TP-08, 16 cycles, 10 hrs/cycle, Total Hours = 160 at 2100°F in Air)

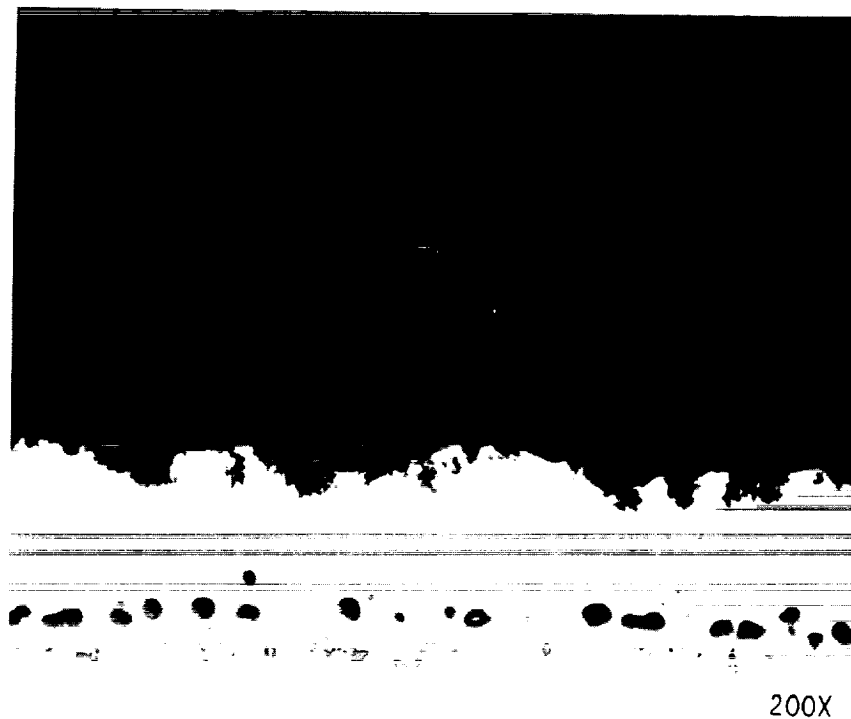
Figure 11 Light Photomicrograph of Post-Test Microstructure. Failed After Furnace Exposure in Air at 2100°F with 10 Hours Inspection Intervals (160 hrs/16 cycles)

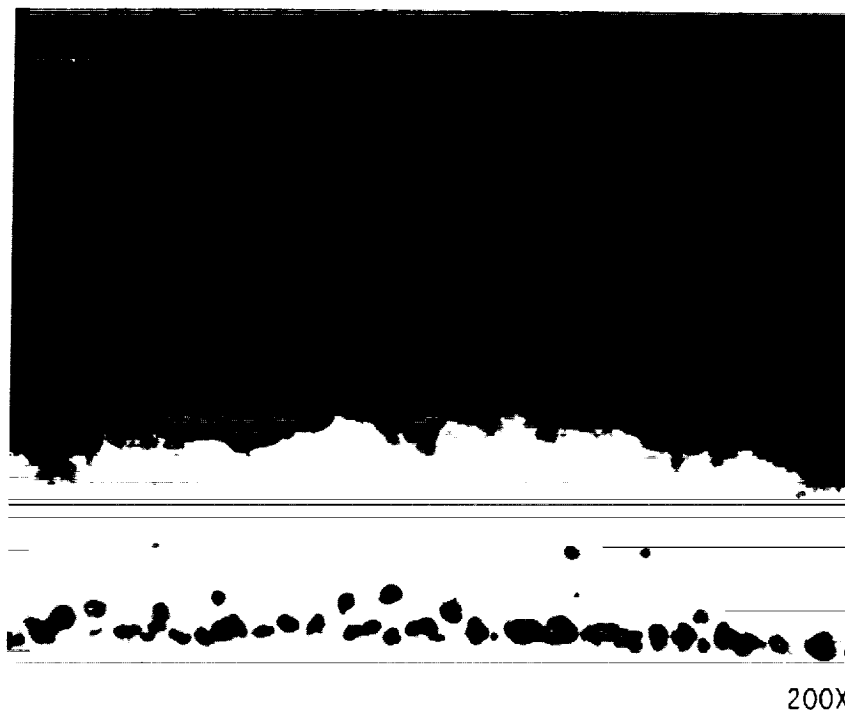
Figure 12 Light Photomicrograph of Post-Test Microstructure. Failed After Furnace Exposure in Air at 2200°F with 10 Hours Inspection Intervals (60 hrs/6 cycles)

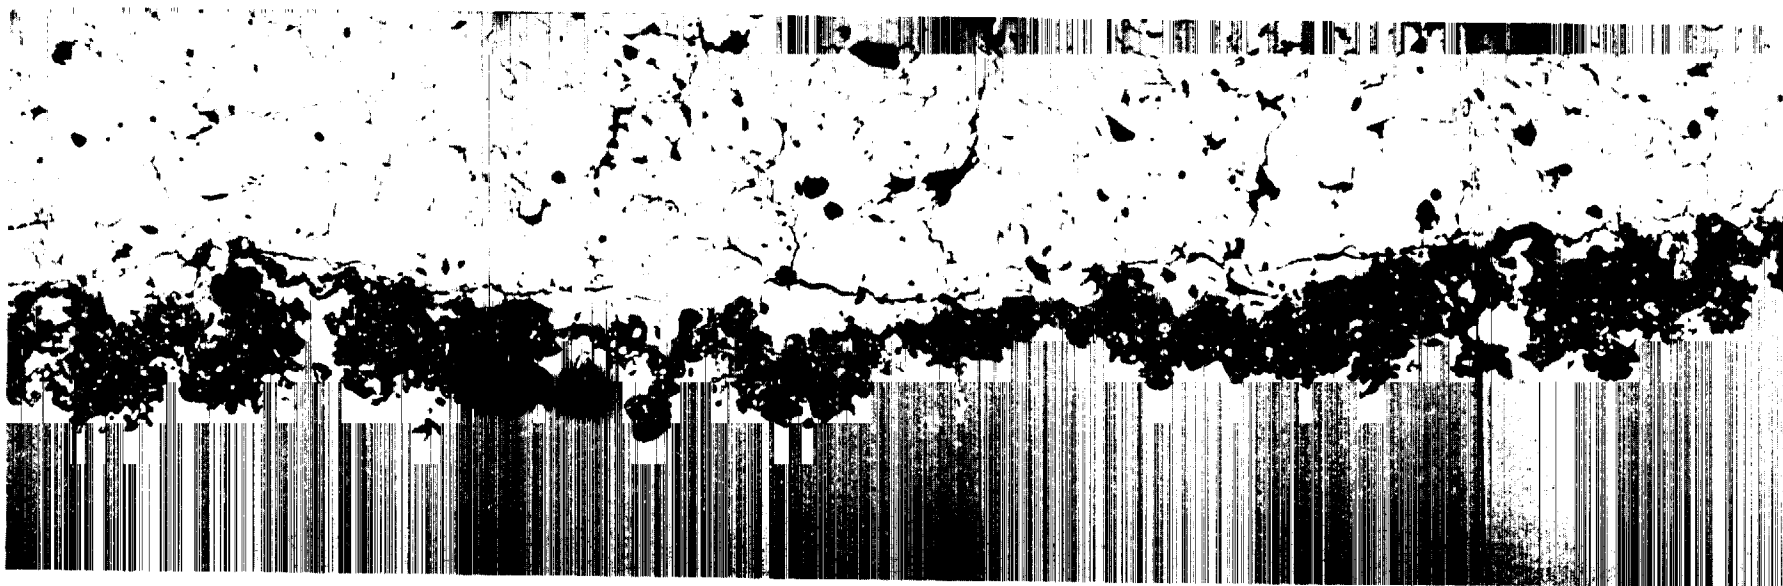
Figure 16a Back Scatter Image of Post-Test Microstructure. Furnace Exposure in Argon at 2100°F for 1040 Hours (80 hour cycles - 13 cycles)

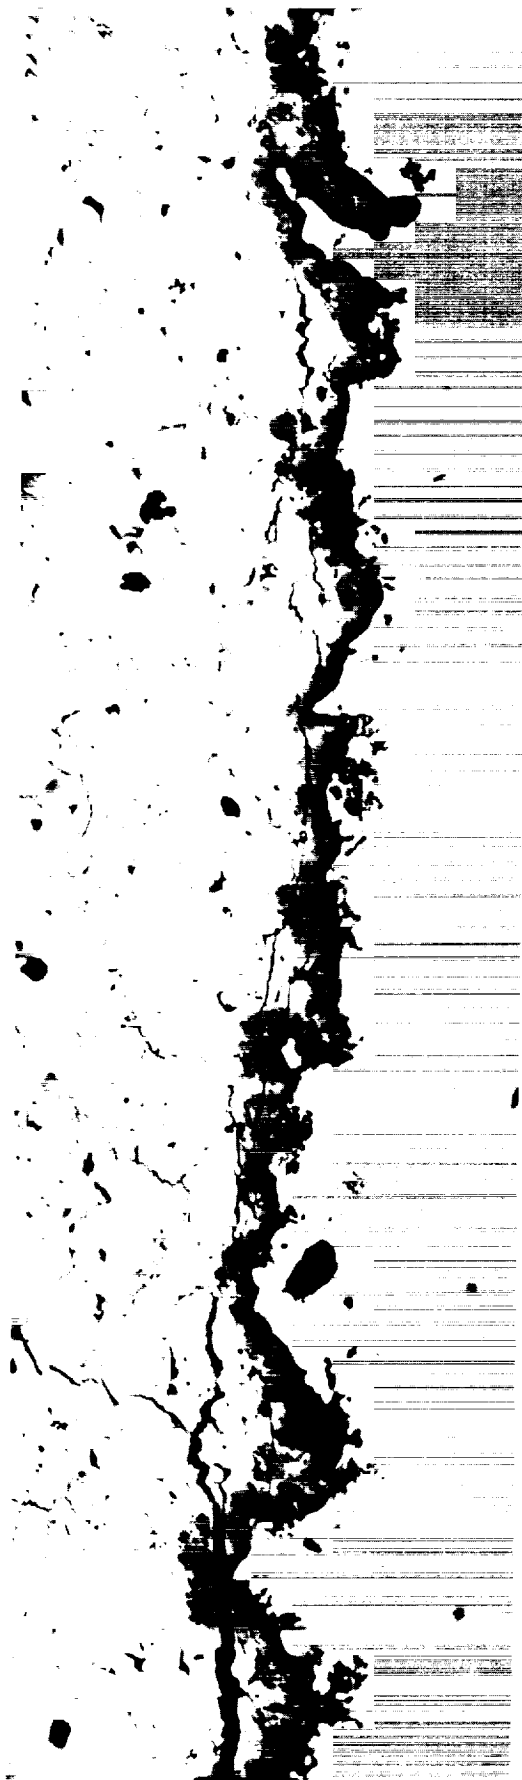
Figure 18a Back Scatter Image of Post-Test Microstructure. Furnace Exposure  
in Air at 2100°F for 240 Hours (80 hour cycles - 3 cycles)

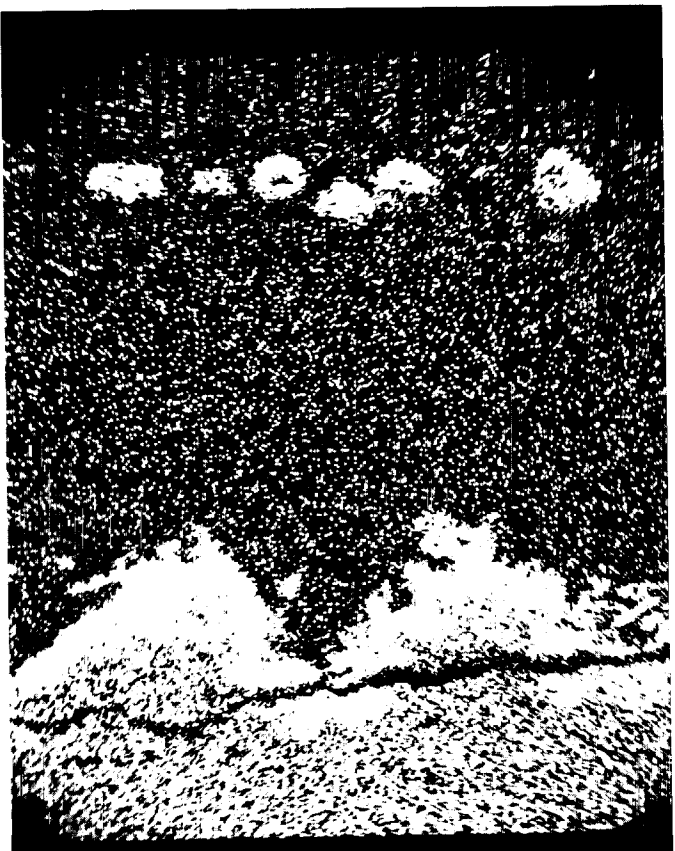
(c)

Figure 19a - j BSI of Post-Test Microstructure. Furnace Exposure in Air at 2100°F for 240 Hours (80 hour cycles - 3 cycles)

O X-RAY MAP

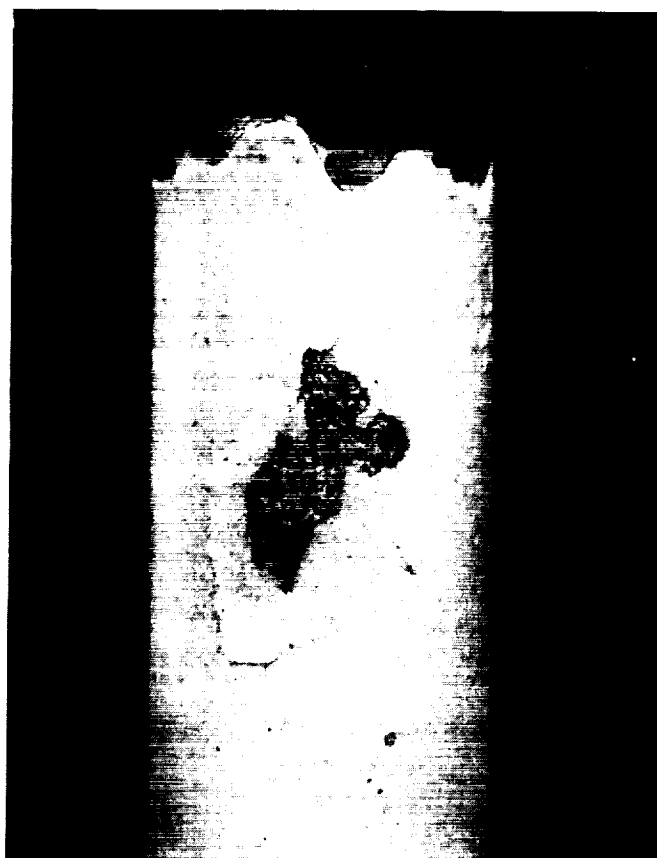
Figure 52 Cyclic Hot Corrosion Test Specimen Showing Multi-level Flaking of the Ceramic

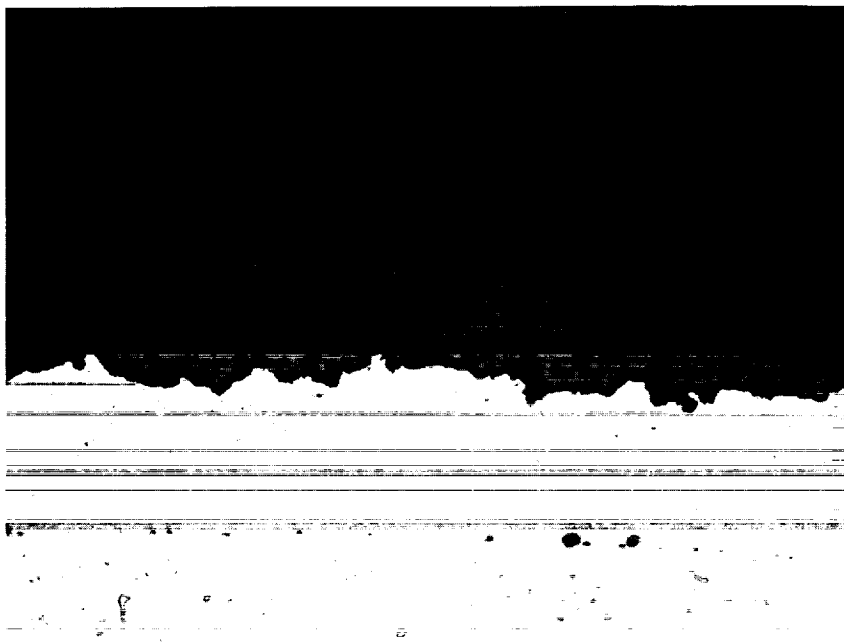
Figure 53b Post-Test Hot Corrosion Test Specimen Showing In-Plane Ceramic  
Cracking in Central and Upper Portion of Ceramic Layer After 693  
hrs at 35 ppm Artificial Sea Salt/1650°F/1 Hour Cycle

Figures 53 and 54(a and b) show the pre-test and post-test microstructures of specimens tested 693 and 1000 hours respectively. The ceramic spallation mode seen in these structures clearly is different from that observed in clean fuel burner rig test failures, exhibiting multi-level in plane, ceramic cracking and flaking, as opposed to the predominant near interface cracking seen in clean fuel failure.

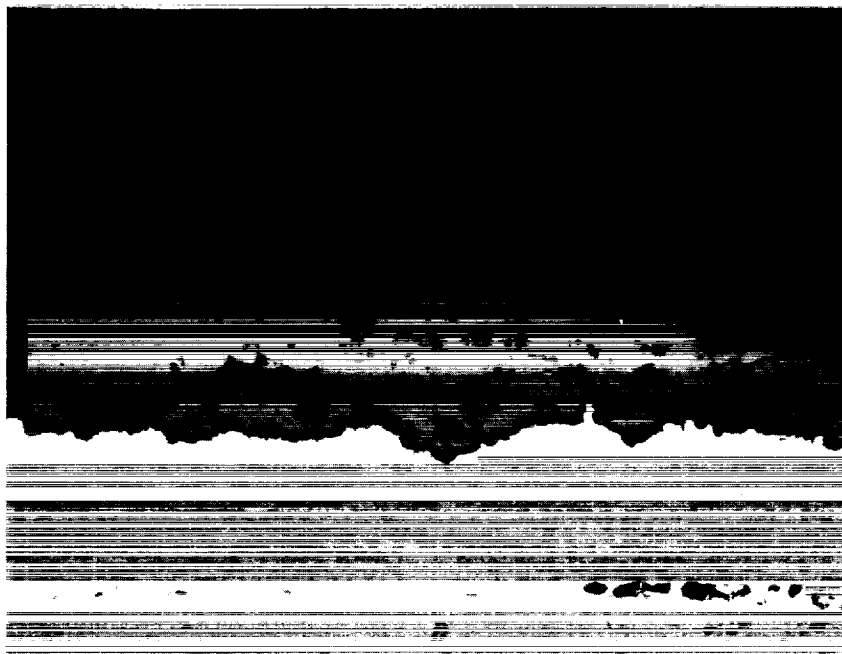
Figure 54b Post-Test Hot Corrosion Test Specimen After 1000 hrs at 35 ppm  
Artificial Sea Salt/1650°F/1 Hour Cycle

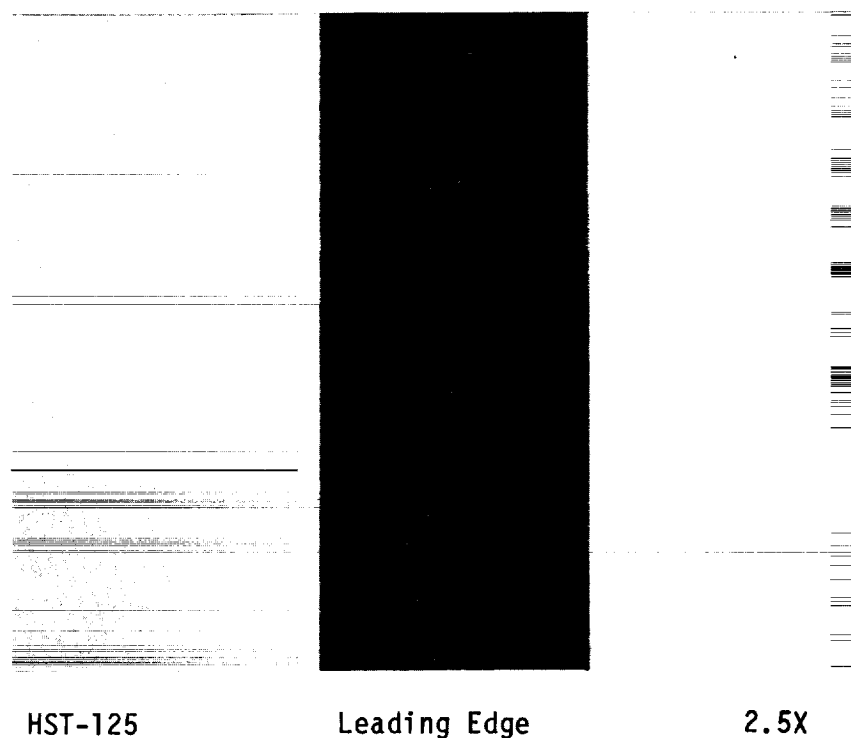
Figure 58 Light Photomicrograph of Test Specimen After 1000 hrs at 1650°F/  
Long Cycle/10 ppm Synthetic Sea Salt/1.3%  $\text{SO}_3$  - Condition J

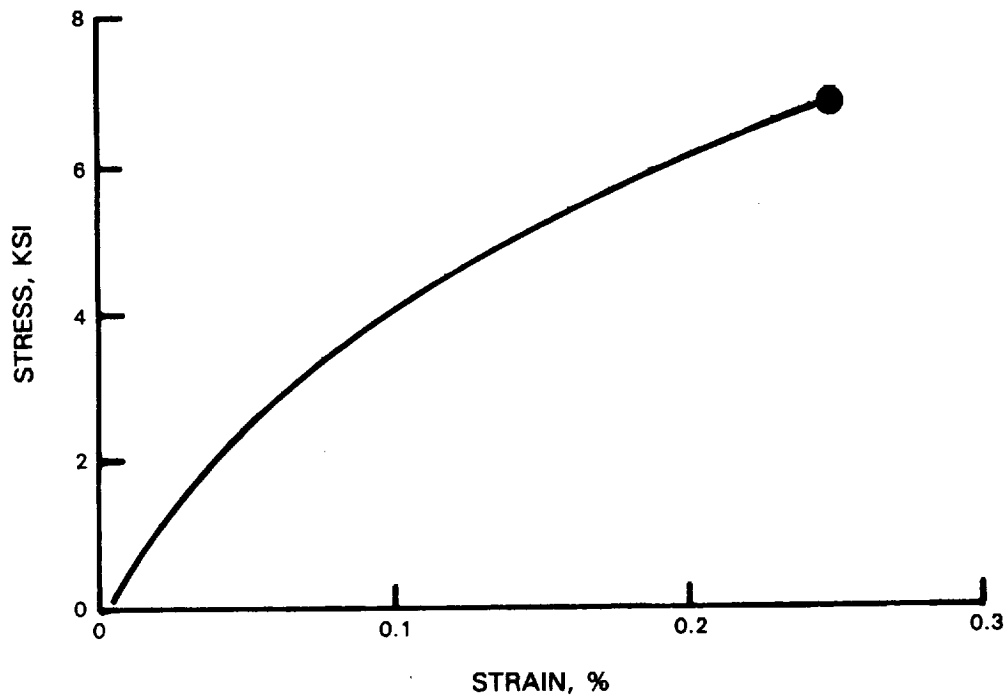
Figure 64a Significant Inelastic Deformation Observed, Room Temperature Four Point Bend Test results for Bulk Plasma Sprayed 7 w/o  $Y_2O_3$  -  $ZrO_2$

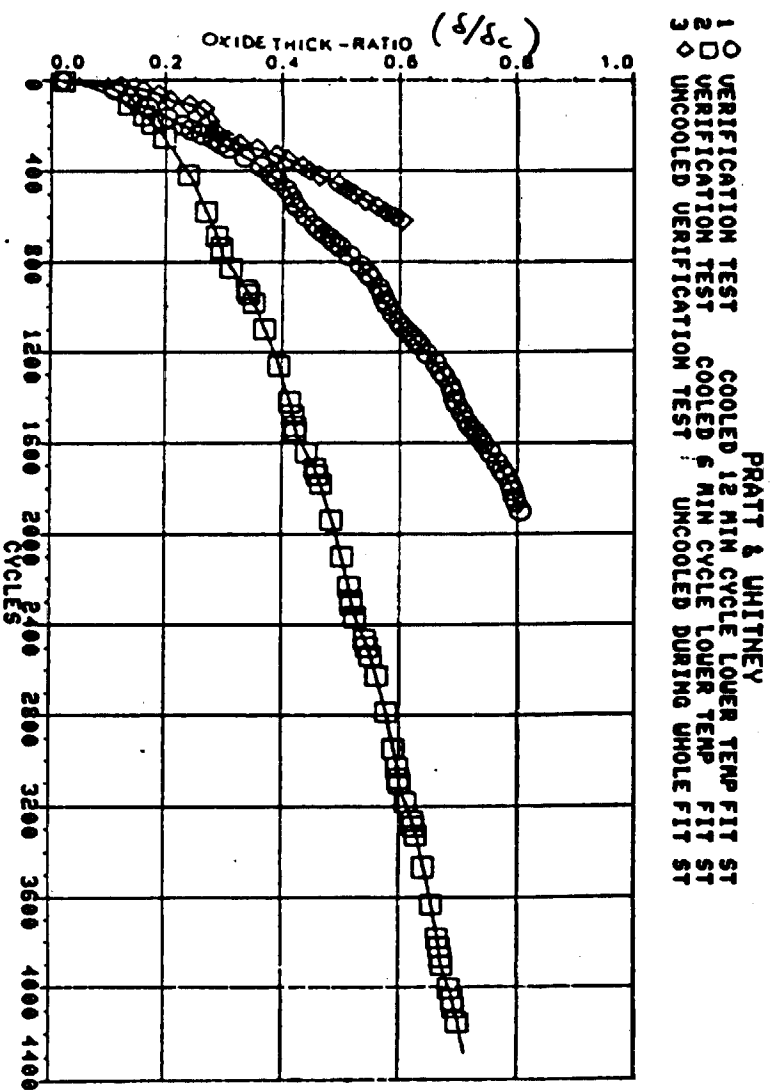
Figure 88 Ratio of Accumulated Oxide Thickness to Predicted Critical Oxide Thickness at Failure Versus Cycle Number Plot for the Three Verification Tests
